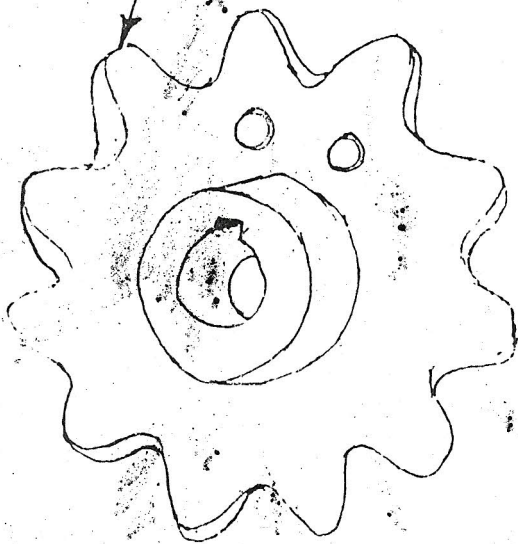
A-A231 SPROCKET ASSEM.  
WITH 3/16 ROD

3/16 ROD AS STOPS

LINSATISFACTORY

If any of (a), (b) or (c) are found unsatisfactory, replace the sprocket within the next ten (10) hours or by Dec. 1, 1978. If above are found satisfactory, new sprocket must be installed within next fifty (50) hours in time in flight or by May 1, 1979. Until then reinspect per this bulletin every ten (10) hours.

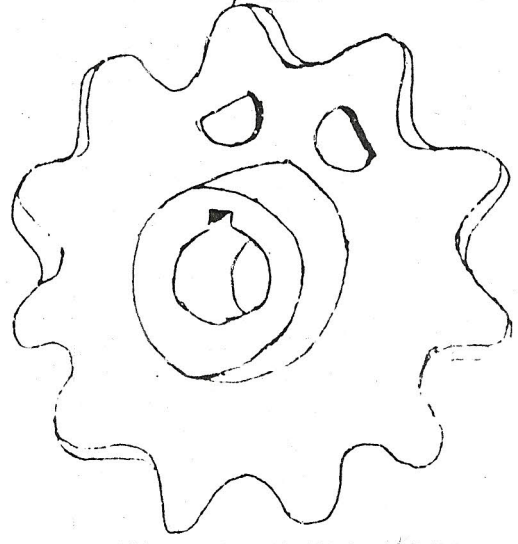
A-A231 SPROCKET  
ASSEM. WITH AN393  
CLEVIS PIN

AN393 CLEVIS PIN AS STOPS

SATISFACTORY
