SERVICE BULLETIN

Service Bulletin No. 2007-002
Date: November 8, 2007

Inspection of: wing strut attach fitting part number A-A11 for cracks or corrosion.

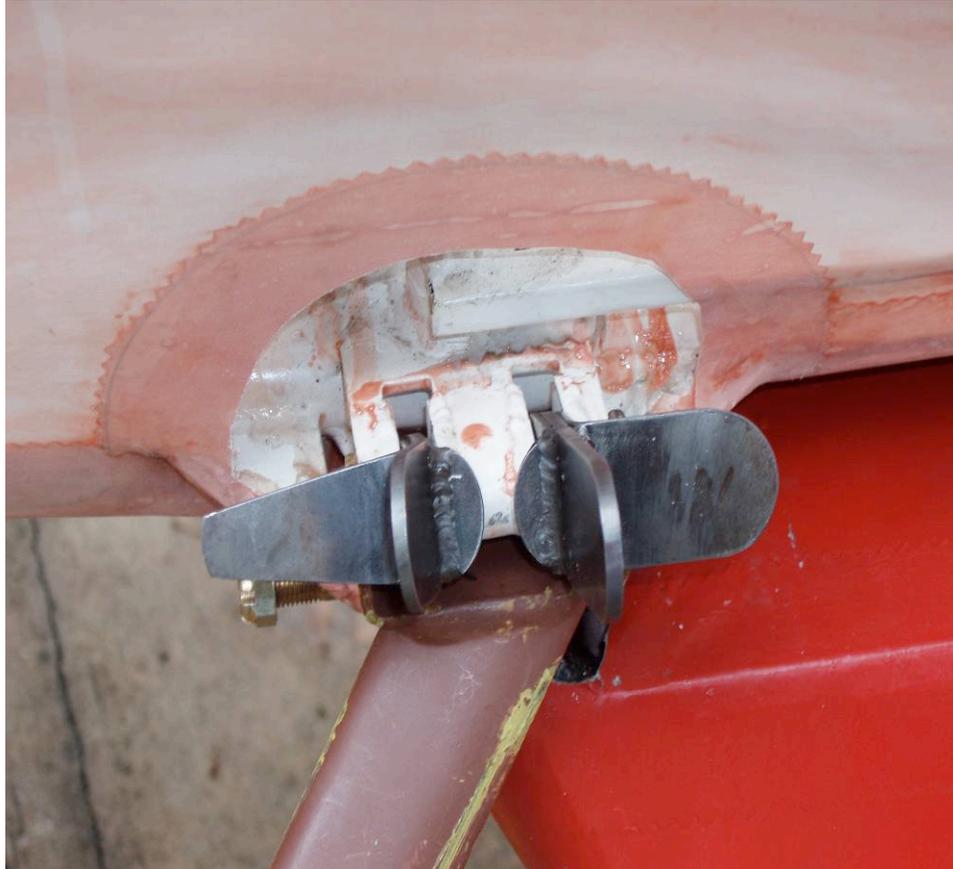
1. Remove landing gear to fuselage fairings L/R side.
2. Remove any aircraft fabric that is attached to the actual lower wing strut attach fitting. Use a razor to carefully cut and remove the fabric from the lower fuselage longerons up and around the strut attach fitting, leaving a minimum 1/2" gap around the strut attach fitting. Take care not to scratch the protective coatings or primer (see photo #1).

Fig. 1 Cut Fabric as Shown (Strut Ends Only Shown for Clarity)

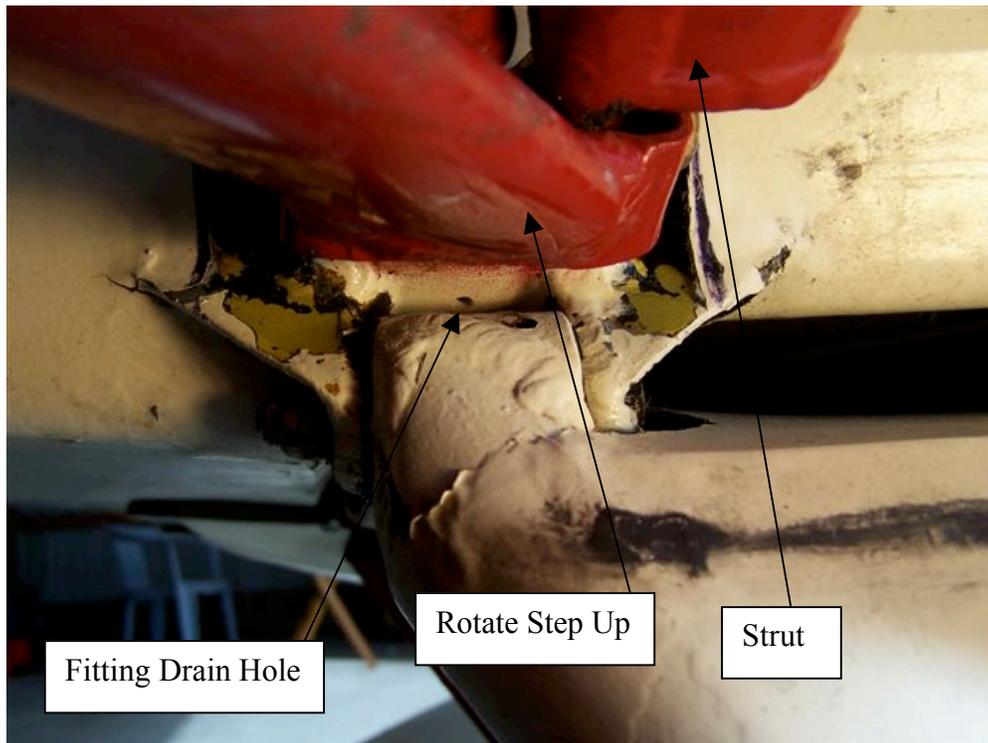
3. Remove all dirt, mud, fabric scraps, fabric glue residue, and any other foreign debris from external and/or internal surfaces of the fitting.
4. Lift up and rotate the step to allow a thorough visual inspection of the underside of the attach fitting. Use a strong light source and a small inspection mirror. Verify that the **drain hole** is open and clean using suitable metallic probe (see photos #2a & 2b).

Fig. 2a Rotate Step Upward to Expose Fitting Lower Surface and Drain Hole

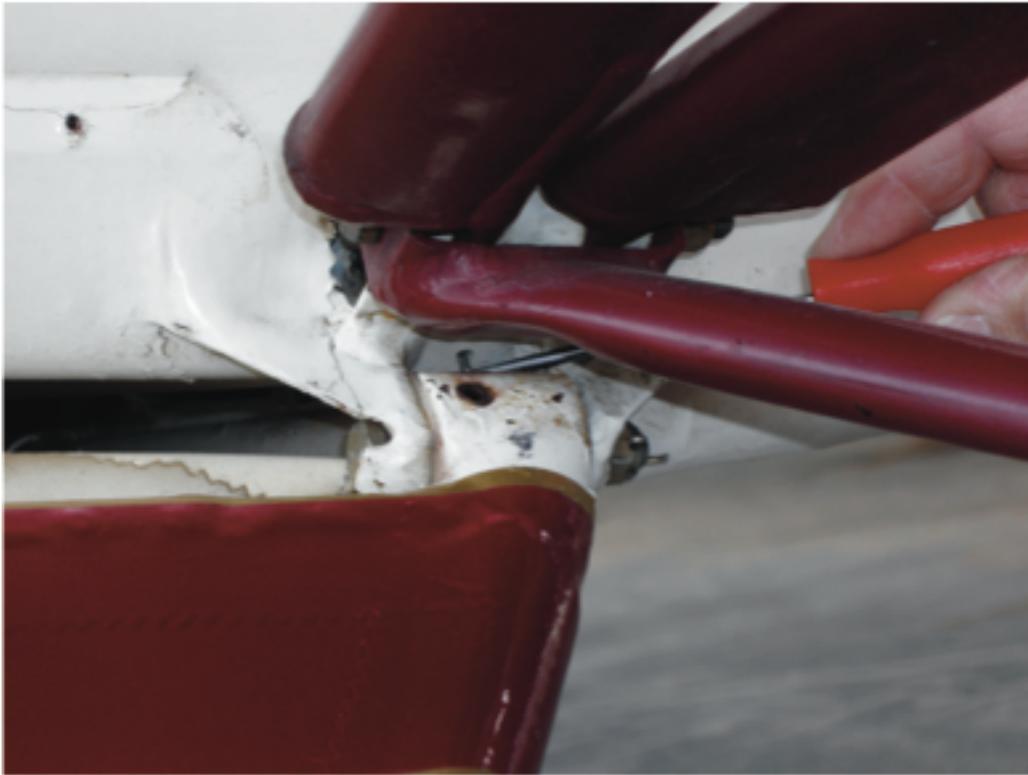
Fig. 2b Verify Drain Hole is Open

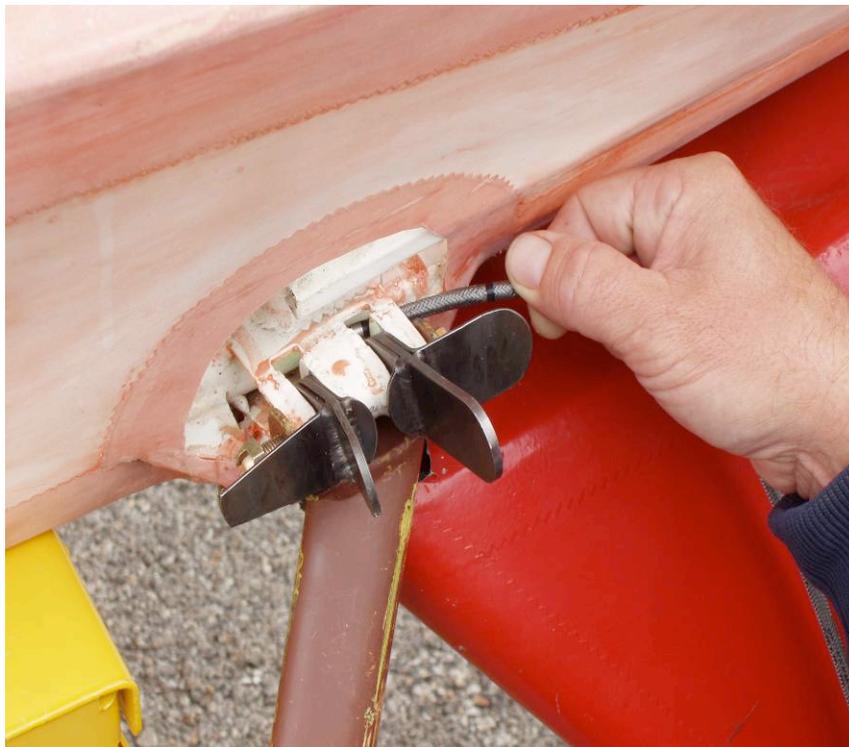
- Pay particular attention to the inner lug area between the two struts (see photo #3 & 4) (Reference AC 43.13-1B, Chapter 5, Section 2 for visual nondestructive inspection).
7. If any signs of blistered paint, cracks or corrosion are discovered during this inspection, perform Part 2 of these instructions prior to further flight.
 8. Touch up any damaged or missing paint or protective coatings with primer and paint in accordance with Part 2.
 9. Repair the area around the fitting with an aircraft fabric patch, using aircraft fabric, coatings, and chemicals approved for the fabric system used in the aircraft. This fabric repair shall not extend over, cover, or restrict future visual access to the fitting. No ends or clippings of the new fabric repair are to be “tucked” into the fitting or cover up the drain hole.
 10. Reinstall L/R side landing gear to fuselage fairings.

7. When the clean bare metal has been exposed, make a further visual inspection using a ¼” **borescope** to determine the severity of any pitting, loss of material, cracks, or other defects (see photo #3).

Fig. 3 Borescope Inspection (Strut End Fittings only shown to enhance view)

8. If any amount of material has been lost in the fitting due to corrosion, or a crack has been discovered, the attach fitting must be repaired or replaced before the aircraft is returned to service. Contact Taylorcraft Aviation for factory approved repairs or replacement procedures.

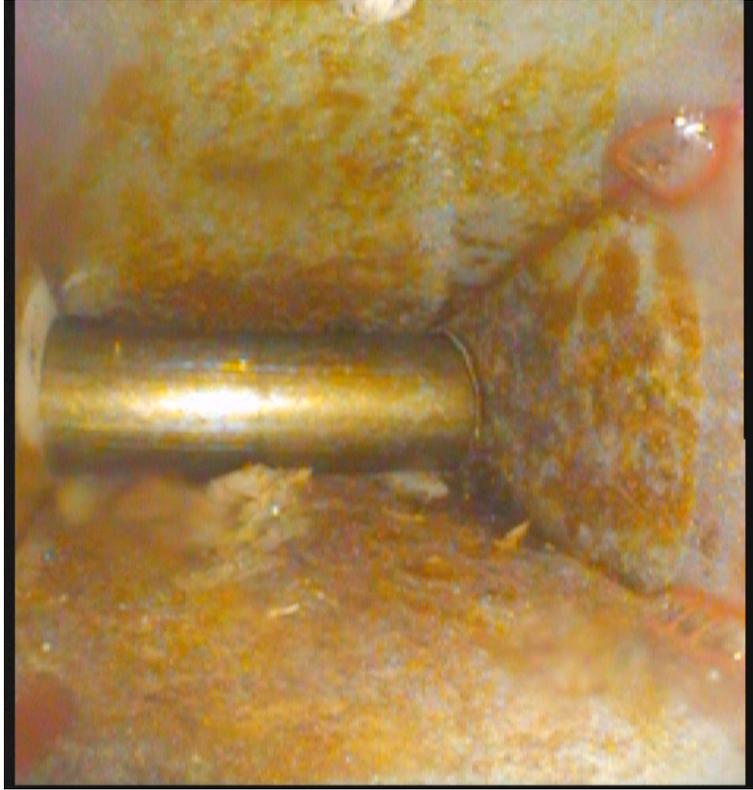
Fig. 4 Borescope View - Inside Center Lug Cavity
