**MAJOR REPAIR AND ALTERATION**  
**(Airframe, Powerplant, Propeller, or Appliance)**

| 1. Aircraft | Nationality and Registration Mark<br><b>N3576T</b> | Serial No.<br><b>F-042</b> | |
| | Make<br><b>TAYLORCRAFT</b> | Model<br><b>F19</b> | Series |

### 8. Description of Work Accomplished

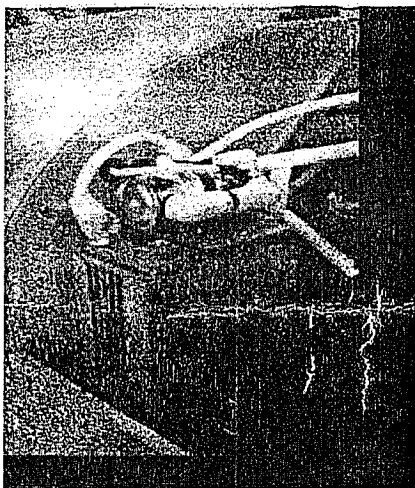
8) Picture below is typical representation of installation location and is from Taylorcraft F-19 N3572T serial # 033.

1) Removed original battery box, cable and contactors from baggage area. Mounted new FAA PMA part# 180185L battery box supplied by Burls Aircraft Rebuild, Chugiak, AK (907) 688-3715 on forward side of firewall on the right side (see attached diagram). Battery box installed I.A.W. Burl's Aircraft, LLC drawing # [180185L/S/HS Install, Cessna] and installation Instruction No. 180185LS-HS.

3) Relocated original master contactor to the firewall adjacent to the battery. Fabricated new battery cables using #2 gauge milspec wire M22759/16-2 and crimp on fittings. Electrical configuration is identical to the original factory configuration. All wiring done in accordance with AC 43.13-1B, Chapter 11, Section 6 (Aircraft Electrical Wire Selection), Section 7 (Table of Acceptable Wires), Section 8 (Wiring Installation Inspection Requirements), Section 11 (Clamping) and Section 15 (Grounding and Bonding) and CAR3, paragraph 3.693 (Electrical Cables).
