**SUBJ:** Main Landing Gear

This Special Airworthiness Information Bulletin (SAIB) informs registered owners/operators of Taylorcraft airplanes (including all **Taylorcraft, Inc., Taylorcraft 2000, LLC, and Arizona Aerospace Foundation** model aircraft under type certificate data sheets **1A9, 1A11, TG-6, A-643, A-696, A-699, A-700, A-746, and TG-6**) with main landing gear (MLG) tie strut part number (PN) B-A51 of an airworthiness concern. Specifically, this SAIB provides guidance on mitigating action to prevent your MLG tie strut from failing due to corrosion.

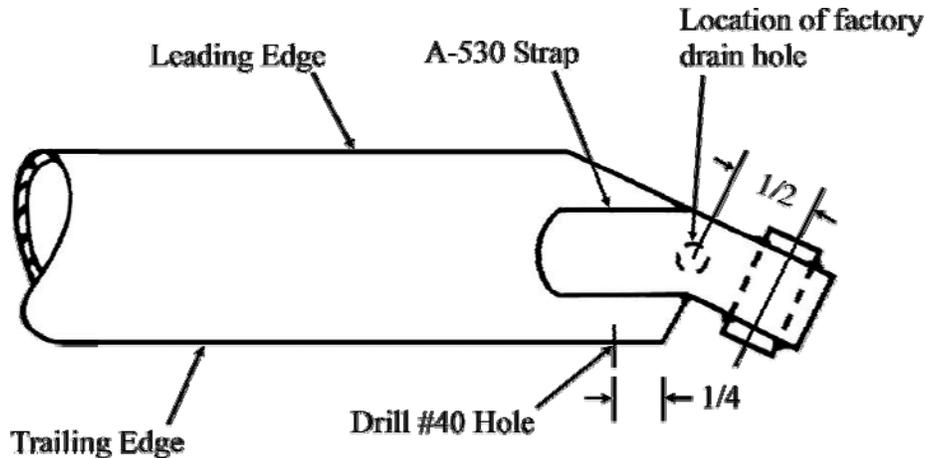
- 1) Remove any fairings as necessary to gain access to the lower portion of the gear leg for inspection.
- 2) Locate the factory-installed drain hole located either on in the PN A-530 strap that attaches the lower lug to the strut tube, or at the trailing edge of the tie strut (See Figure 1). In the absence of a factory-installed drain hole at either location, locate and drill a #40 drain hole in

Figure 1: MLG Tie Strut Lower End with Factory Drain Hole in A-530 Strap Lower Surface or in Strut Trailing Edge

- 3) Inspect the area around the drain hole and note any water draining from, or rust particles exiting, the hole. Insert a wire or #40 drill bit into the drain hole and inspect it for the presence of rust particles.
- 4) If any rust particles or debris are noted while performing step 3, do the Additional Inspection Procedure below as necessary.
